This handout is provided to meet the requirements of the OSHA asbestos awareness refresher training for custodial and housekeeping workers and Class IV asbestos workers. This training allows you to:

What is Asbestos?

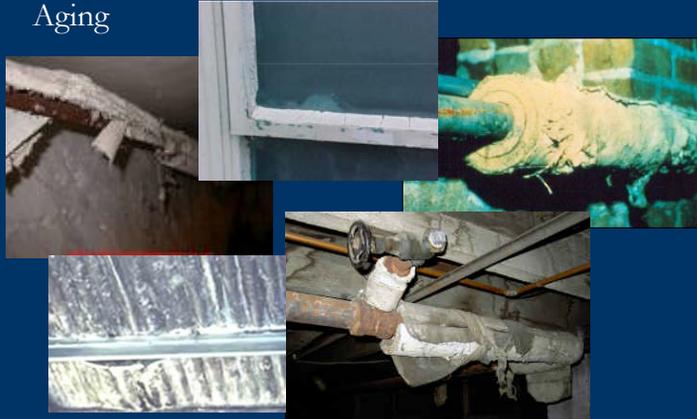
9

Recognition of Damage, Deterioration, & Delamination

Aging

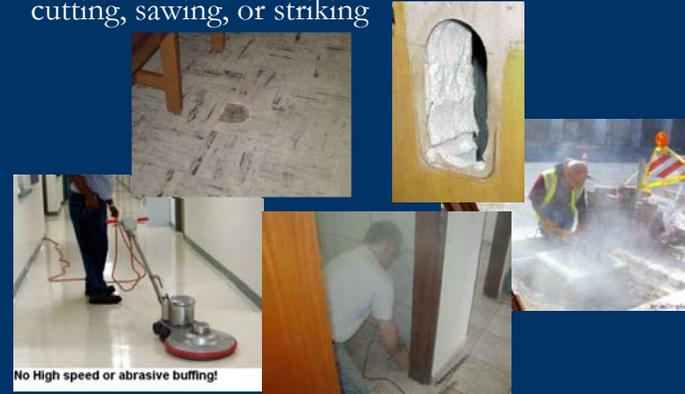
10

Recognition of Damage, Deterioration, & Delamination

Physical impact such as drilling, grinding, buffing, cutting, sawing, or striking

No High speed or abrasive buffing!

- Care of asbestos-containing flooring material.
 - Sanding of asbestos-containing floor material is prohibited.
 - Stripping of finishes shall be conducted using low abrasion pads at speeds lower than 300 rpm and wet methods.

- Burnishing or dry buffing may be performed only on asbestos-containing flooring which has sufficient finish so that the pad cannot contact the asbestos-containing material.
